**Q08. My system is Win7/Win8/Win10, and I cannot connect WF-2000 via Ad-Hoc network, what should I do?**

**Q09. What is the difference between the Ver.B and the older version firmware?**

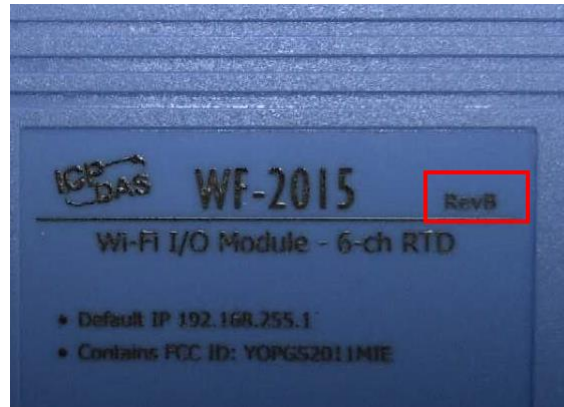
(a) To find the “RevB” mark on the mechanism.

If Users find the “RevB” mark and read the FW information B.x from the Utility. The module must be configure with the Utility of the RevB version. If not, please download the correct Utility version for the configurations.
